AN ENGINEERING ANALYSIS OF THE GRAND ISLAND, NE TORNADOES

Timothy P. Marshall and James R. McDonald
Institute for Disaster Research
Texas Tech University
Lubbock, Texas

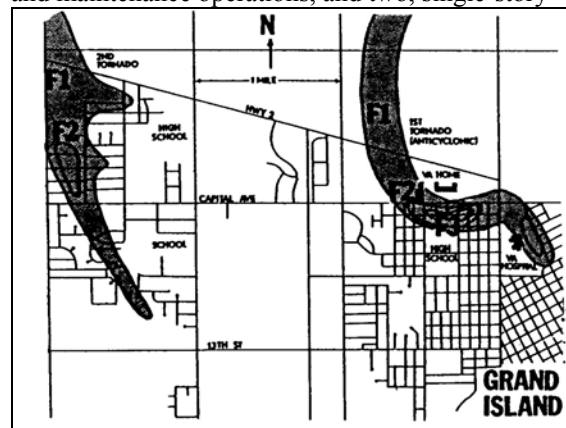
The first tornado entered the city shortly after 9 p.m. CDT (Fig. 1). Debris patterns, as well as radar images, showed that the tornado rotation was anticyclonic. The tornado traveled southward through relatively open farmland until it reached Capital Avenue, where it made a sharp left turn toward the east. Residential damage along Capital Avenue was heavy, having the appearance of F3 damage on the F-scale classification system. The width of the tornado damage path was approximately 1000 feet.

Figure 1. Tornado paths in northwest Grand Island as determined by extensive ground and aerial damage surveys. Gradations of damage are based on the F-scale.

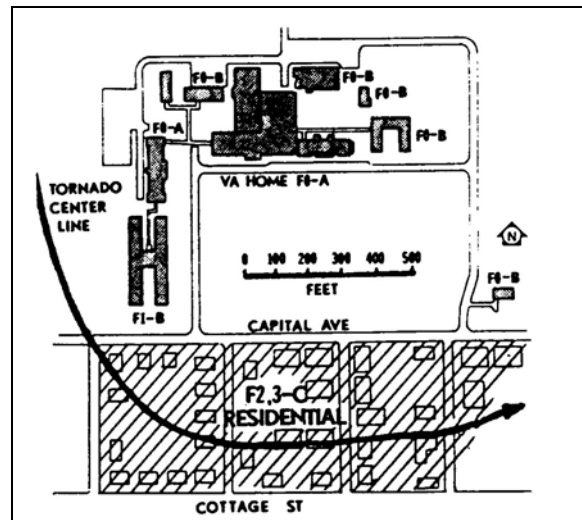
The Nebraska Veterans Home complex is located on the periphery of the tornado damage path (Fig. 2). The building complex consists of several three-story institutional-type buildings, several old buildings

Figure 2. Plot plan of the Nebraska Veterans home complex and residential area to the south. building damages are classified according to the

F-scale and type of building. (A-engineered, B-marginally-engineered, C-non-engineered)

living quarters (Annex buildings). The three-story buildings had received obvious engineering attention in the design. Damage was confined to broken windows, loss of roofing material, and the loss of fascia and decorative materials. The older buildings were in need of renovation prior to the storm. Nails that anchored the timber decking to the roof trusses had no doubt loosened with age making the roof more susceptible to uplift forces. The one-story building, that housed the physical therapy facility, had a relatively new synthetic rubber membrane roof that was covered with large gravel. Instead of the usual 1/4 to 1/2-inch diameter aggregate size, the aggregate averaged one inch in diameter. The pressure deficit under the membrane, either due to the atmospheric pressure change or the aerodynamic pressure, gave an initial acceleration to the roof gravel that allowed the larger gravel to travel longer distances than the smaller gravel on the three-story buildings built-up roofs. As a result, the impact of the larger size roof gravel did considerably more damage to window and exterior finishes. Evidence of roof gravel was found on several window sills and in the interior of several buildings throughout the complex.

The annex buildings suffered loss of roof material and partial loss of plywood roof decking in the vicinity of the eaves, ridges, and corners where localized pressures are larger than overall pressures. The roof system consisted of gabled timber trusses which span 45 feet between the loadbearing walls. Most of the trusses remained in place after the tornado, despite the fact that they were only toenailed in place. This weak anchorage to the walls suggests that winds were not very strong on the northern periphery of the tornado.

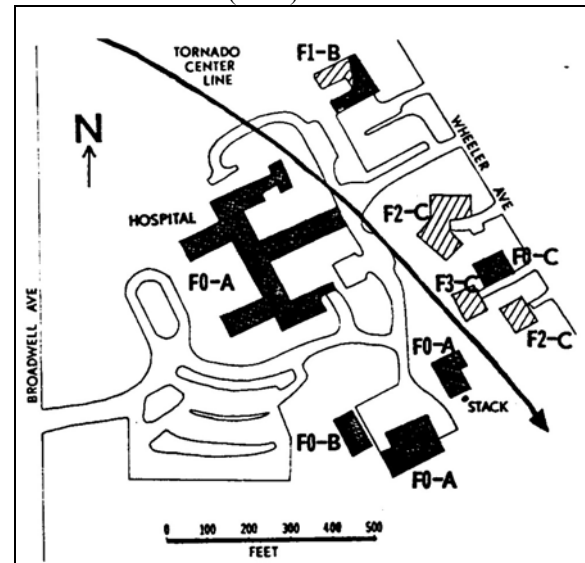
The tornado continued eastward for five blocks before striking the VA Hospital (Fig. 3). The tornado appeared to have weakened since the residential damage northwest of the hospital was lighter in magnitude than near the VA home. The hospital is a seven-story, steel reinforced concrete frame with brick masonry for exterior cladding. The damage was limited to broken windows and loss of some lightweight concrete canopies over two sun porches on the fifth floor. Again, roof gravel became airborne and impacted several windows (Fig. 4). Breach of the building containment resulted in wind

Figure 3. Plot plan of the Nebraska Veterans Hospital (dark shaded). Buildings with structural damage are hatched and classified according to F-scale and type (A-engineered, B-marginally-engineered, and C-non-engineered.)

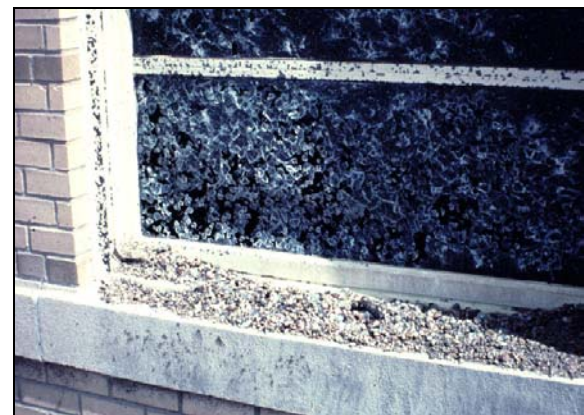
and water penetrating into the interior of the building. Though the building didn't sustain structural damage, the wind and water damage was typical to similar hospital buildings studied by McDonald and Lea (1978).

Figure 4. Damaged safety glass and window frame from roof gravel impacts at Veterans Hospital.

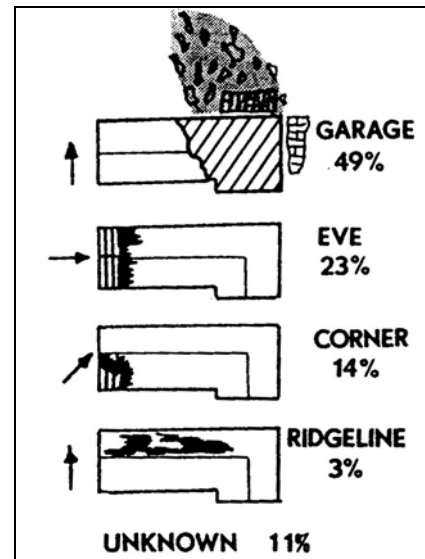
In a few instances, residences that were not anchored to their foundations had slid causing the floor to collapse into the basement. These residences appeared to be totally destroyed among other anchored residences. In addition, various degrees of roof damage were found depending on the direction and speed of the oncoming wind (Fig. 5). Nearly half of the residences with roof damage experienced windward failure of the garage door that led to total garage failure and partial loss of the roof. Other types of roof failure that were less common initiated at the eave, corner, or ridgeline of the residence. Minor et al (1977) has summarized the performance of residential structures in tornadic wind loads from several years of damage investigations. The study concluded that varying construction practices and orientation of the residence to the wind were crucial in relation to the damage intensity.

Figure 5. Percentage of roof damage initiation in the Capital Heights subdivision from a total of 104 damaged residences. Wind vectors show the direction of the oncoming wind.

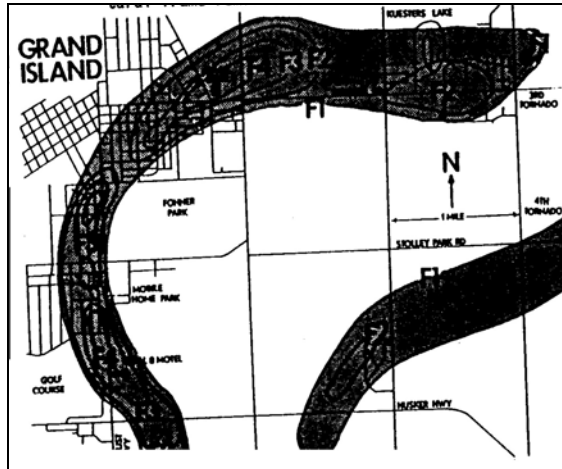
The storm system redeveloped about 10 p.m. CDT and produced a third tornado which was cyclonic (Fig. 6). The tornado developed over an open field and moved westward into the Kuesters Lake subdivision causing F2 damage and uprooting many trees. The tornado continued westward and impacted the Meves Bowling Alley from the northeast (Fig. 7).

Figure 6. Tornado paths in southeastern Grand Island after extensive ground and aerial surveys. Gradations in damage were rated by F-scale.

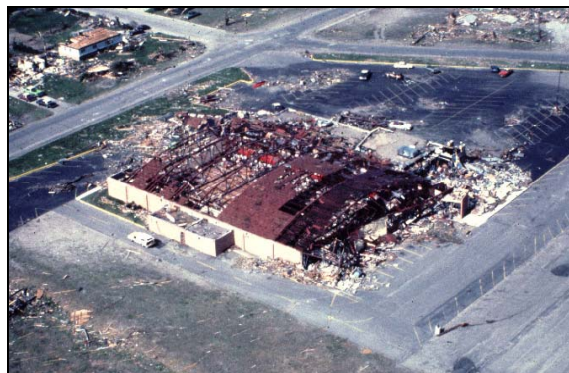
The non-loadbearing north wall blew into the bowling alley and the resulting wind pressures caused the south wall to collapse outward. The classic case of windward and leeward wall failure suggest the same behavior under a tornadic wind load as it would under a straight-line wind load. Most of

the metal roof decking was stripped off and considerable wind damage was done to the interior. However, even though the bowling alley sustained heavy damage, the steel frame remained relatively intact. Based on the surrounding residential damage as well as the damage

Figure 7. Aerial view of Meves Bowling Alley looking toward the southwest illustrating windward and leeward end wall failures.

to the bowling alley, it was determined that this area saw the strongest winds in our damage survey.

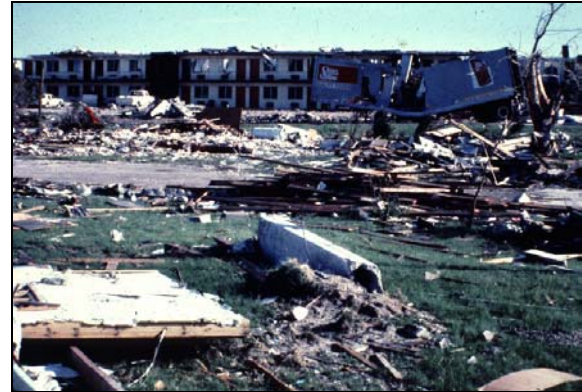
The tornado continued and turned southward traveling along Locust Street for one mile and impacted the Regal 8 Motel. It was at this site that we discovered unusual tornado-generated missiles. The roof system of the motel consisted of several hundred precast concrete planks measuring 24 feet long by 12 inches wide by 8 inches thick and weighing about 600 pounds each (Fig. 8). As the

Figure 8. Concrete plank missile embedded into the ground. The plank originated from the roof of the Regal 8 motel in the background.

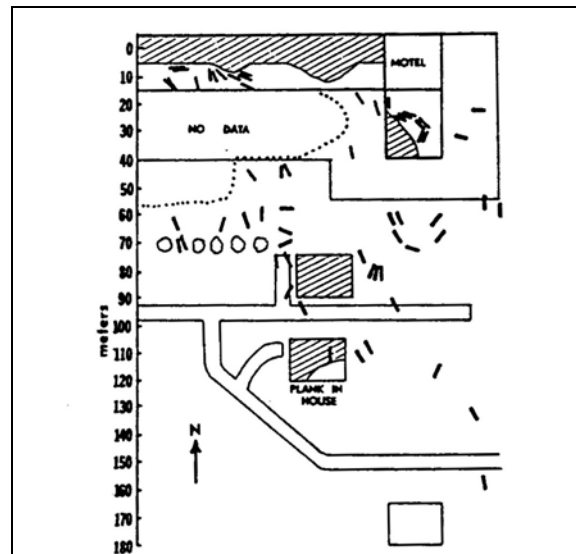
tornado approached the motel from the north, the windward windows failed and the resulting wind pressures inside had lifted the planks. Approximately 200 planks were uplifted of which nearly half became airborne (Fig. 9). Some of the planks traveled more than 100 meters and one struck a residence, passed through an exterior wall, the floor and was found

Figure 9. Locations of concrete roof planks with respect to the Regal 8 Motel. The tornado traveled from northwest to southeast. Hatched areas indicate the locations of missing roof planks.

embedded nearly three feet in the crawlspace. The plank landed just a few feet away from where two persons were seeking shelter from the storm. Most of the planks shattered into small pieces and missile impacts were evident on the ground and road surfaces downwind from the motel. It appeared that the planks were not anchored to the tops of the walls.
